## Effectiveness of the Phoenix MB72 on the UVC sterilisation of complex geometry microphone heads.

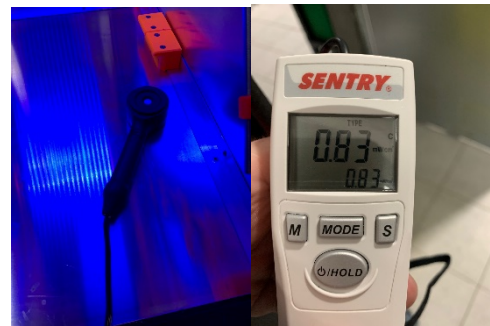
Firstly, UVC transmission through the head without the foam was measured. A lowest level exposure point was found in the chamber and a reading with the UVC sensor pointing away from the light sources

A reading of 83mW/cm<sup>2</sup> was observed.

Figure 1 Baseline UVC exposure level

We can conclude that passing freely through the wire grille and reaching the foam we have approximately 35% of the UVC light passing through the open grille exposing the interior.

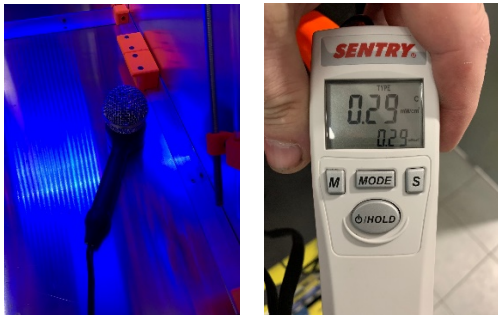
Then a microphone head was placed over the UVC sensor and the level of UVC passing through the head was measured.

Figure 2 UVC levels inside the microphone grille

A reading of 29mW/cm<sup>2</sup> was observed.

We can also conclude that at 0.3 mW/cm<sup>2</sup> (chosen at a low exposure part of the chamber) it would require about 60 seconds to achieve a fully sterilising dose to 99.9% certainty to the foam windshield inside the wire grille head of a microphone for most specified pathogens.

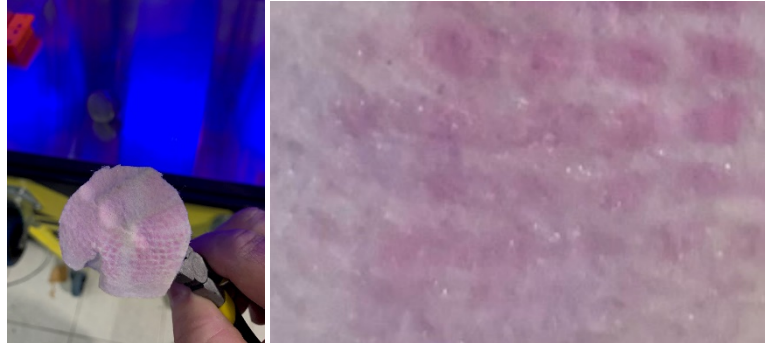
The microphone head was placed central in the chamber and the photochromatic paper was placed pointing away from the side mounted light sources, at the least exposed part of the head. The paper was mounted against the grille where the pop filter sponge would be mounted. After a short exposure 20 seconds the paper was removed and observed.

It was noted that all of the paper was possessing a slight change in colour while the areas exposed directly to the air and light were deeply coloured, areas where the paper was more shaded were more lightly coloured, but still well exposed. As the grille wire is round and does not fully shade anywhere there was good exposure under the wires. This result far exceeded our expectations.

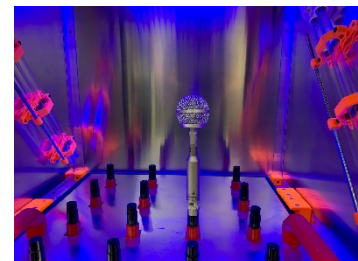
The photochromatic coating was applied. And can be seen to be white in the photograph taken under normal artificial light.

Figure 4 Treated grille unexposed to UVC

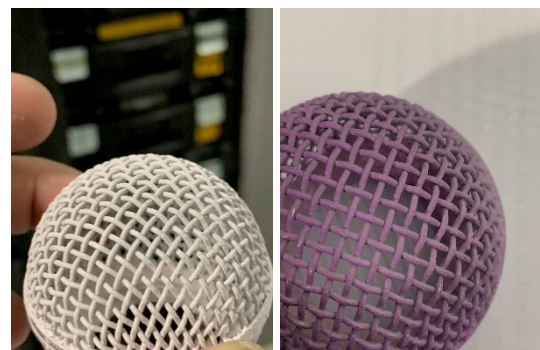
A very strong change of colour was noticed. It was noted that even deep into the recessed areas of the grille we saw a strong change of colour.

Figure 3 Treated grille exposed to UVC

It can be concluded that in the diffuse reflective light chamber of the Phoenix MB72 there is adequate exposure of a complex geometry microphone head to suggest that pathogens will be killed deep into the grille and at least on exposed surfaces of internal foam windshields. Exposure times of 120 and 240 seconds would seem adequate to treat most microphones to the 99.9% recommended level and far exceed the 95% dose.
